Product Announcement

Thicker Shoe Used on Band Brake Assembly

Manaras-Opera Improves It's Band Brake Assembly

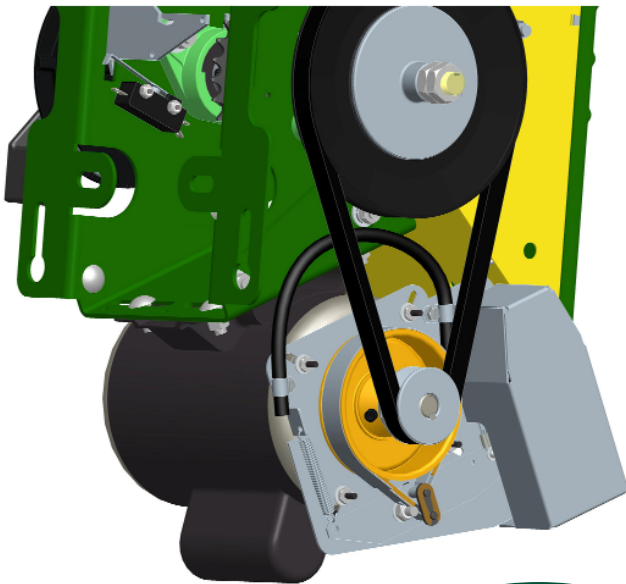
BRAKEPART 019 on Opera-SH >>>

SHOE 026
Thicker metal
band is used

- A thicker metal band **SHOE 026** is being used to support the fiber brake band in our brake assembly **BRAKEPART 019**.
- Improving to **SHOE 026** increases the life span of the brake band, as well as increases the time between maintenance adjustments or component replacements.
- Please note that the replacement component **BRAKEPART 019** replaces **BRAKEPART 017** in the above mentioned assemblies as well as for replacement components.

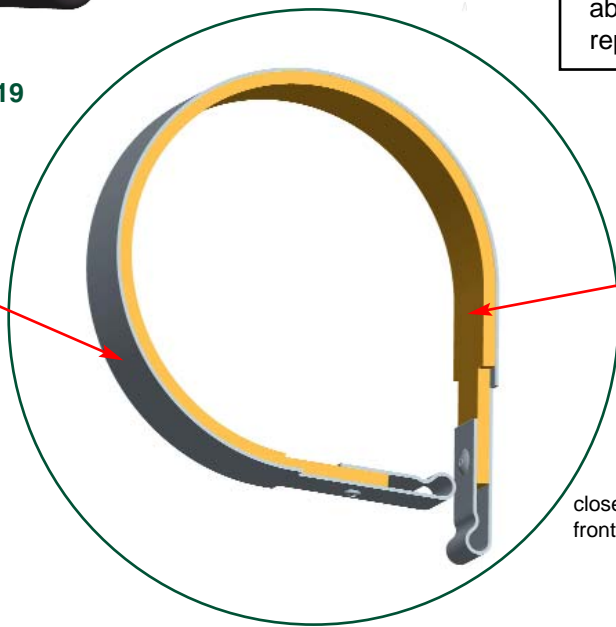
Fiber brake
band

close up
front view
